Repairing Long-Past Damages to Ashworth Creek

Location of the Ashworth Creek Restoration Project

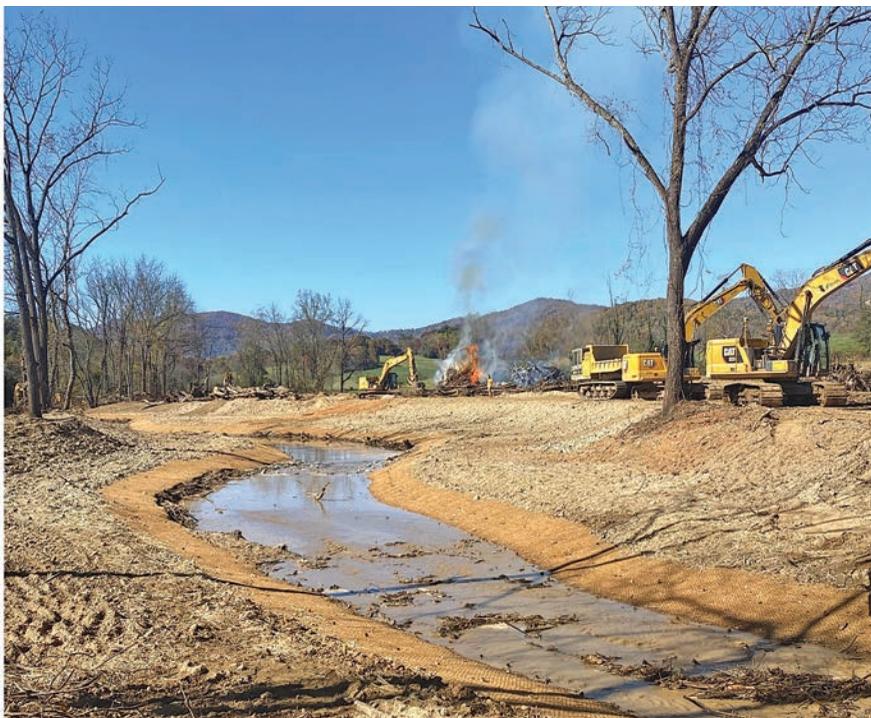
The new, curving channel and more gently sloping banks were created by the heavy equipment in the background. Although many trees were removed, the new plantings will all be native trees and shrubs of much better diversity than the former vegetation.

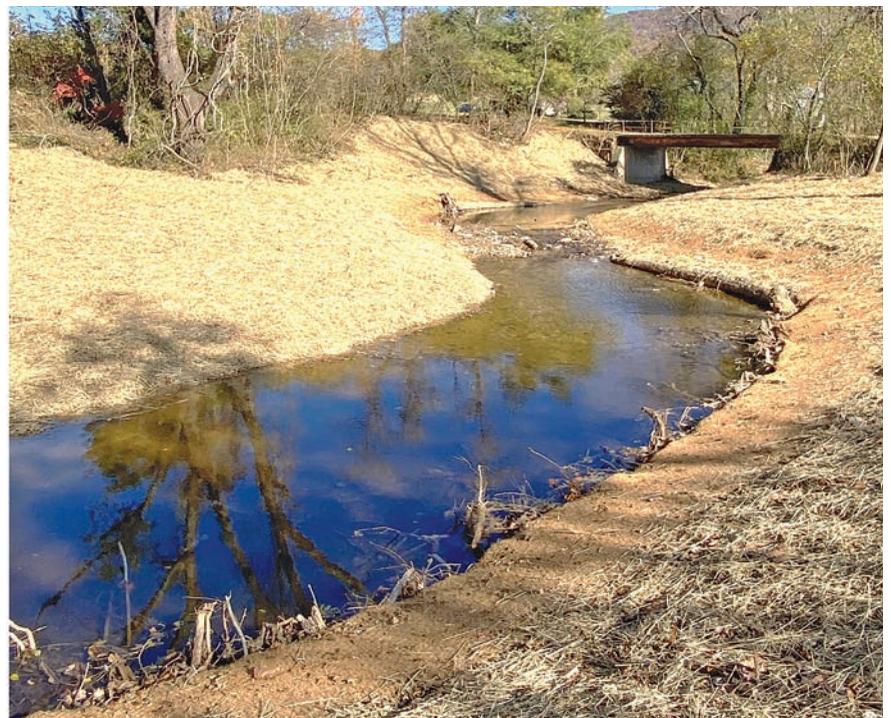
The brush toe technique protects the erosion-prone bottom of the near bank by anchoring stumps and roots all along the water’s edge. Layers of straw and coconut fiber fabric reduce erosion on the upper slopes while new vegetation gets started.

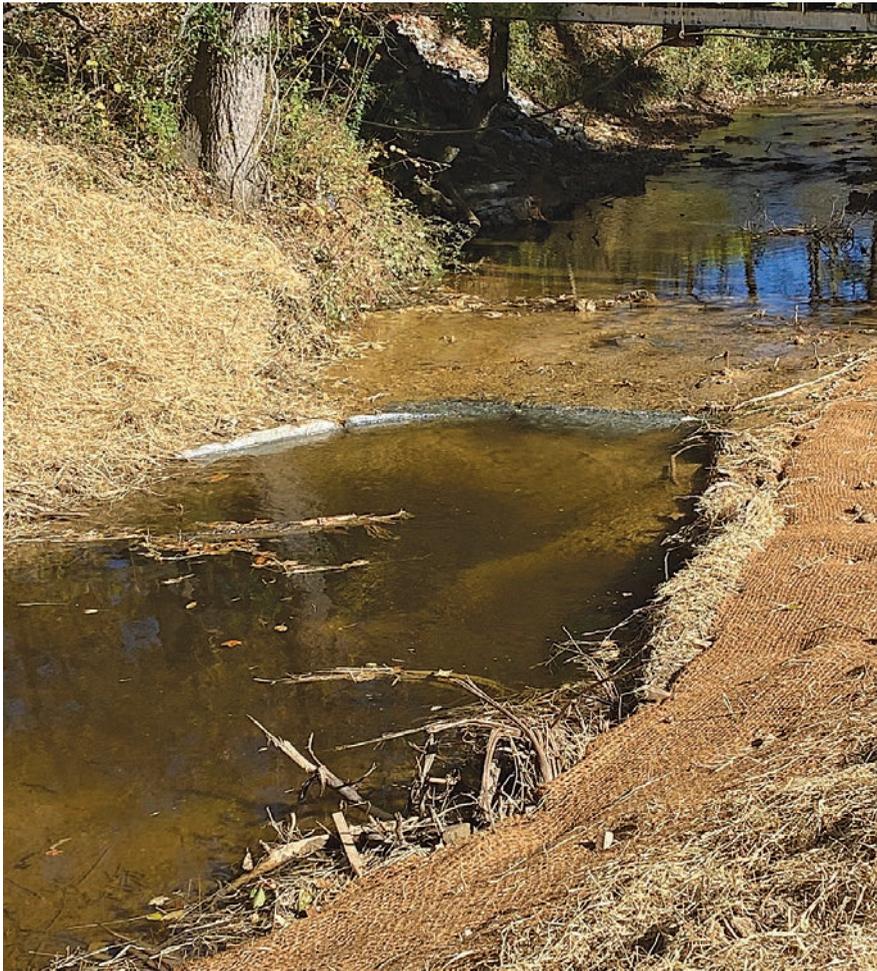
In this log-and-rock vane design, the log (right shore) protects the bottom of the sloped bank while the curve of large rock slabs across the stream directs flow to create a deep pool in the center.

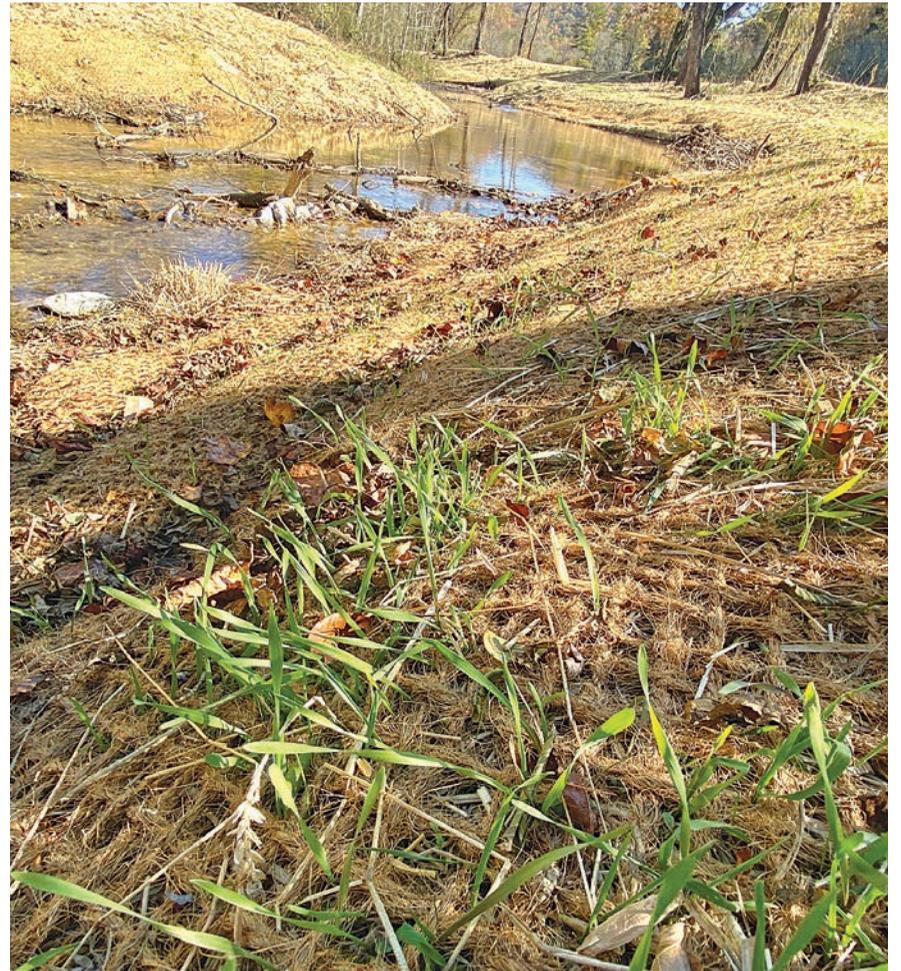
Grasses sprouting through the bank stabilization fabric are just the first of more vegetation plantings yet to come, including a variety of native trees and shrubs.
